**GeoSystems Consultants, Inc.**

August 23, 1993  
Project 93G019

Re: Vesper Boat Club

GeoSystems Consultants Inc. (GSC) is pleased to present this construction monitoring report associated with the compaction grouting program conducted at the Vesper Boat Club (VBC), Boathouse Row, Philadelphia, Pennsylvania. GSC was retained by the VBC via its representative, Mr. Larry Wittig, to observe and document (only) the "compaction grouting" program associated with the party wall between VBC and MALTA Boat Club. The scope of work was expanded verbally during a telephone conversation between Mr. Wittig and Mr. C.R. Calabria of GSC to provide spot documentation of other grouting being performed at the site. These services performed by GSC commenced on 7/June/93, and concluded on 2/July/93. GSC monitored portions of the drilling operation, the compaction grouting operation, and monitored building movement using contractor's level control equipment and a crack gauge installed by MALTA Boat Club to evaluate wall, and floor slab movement.

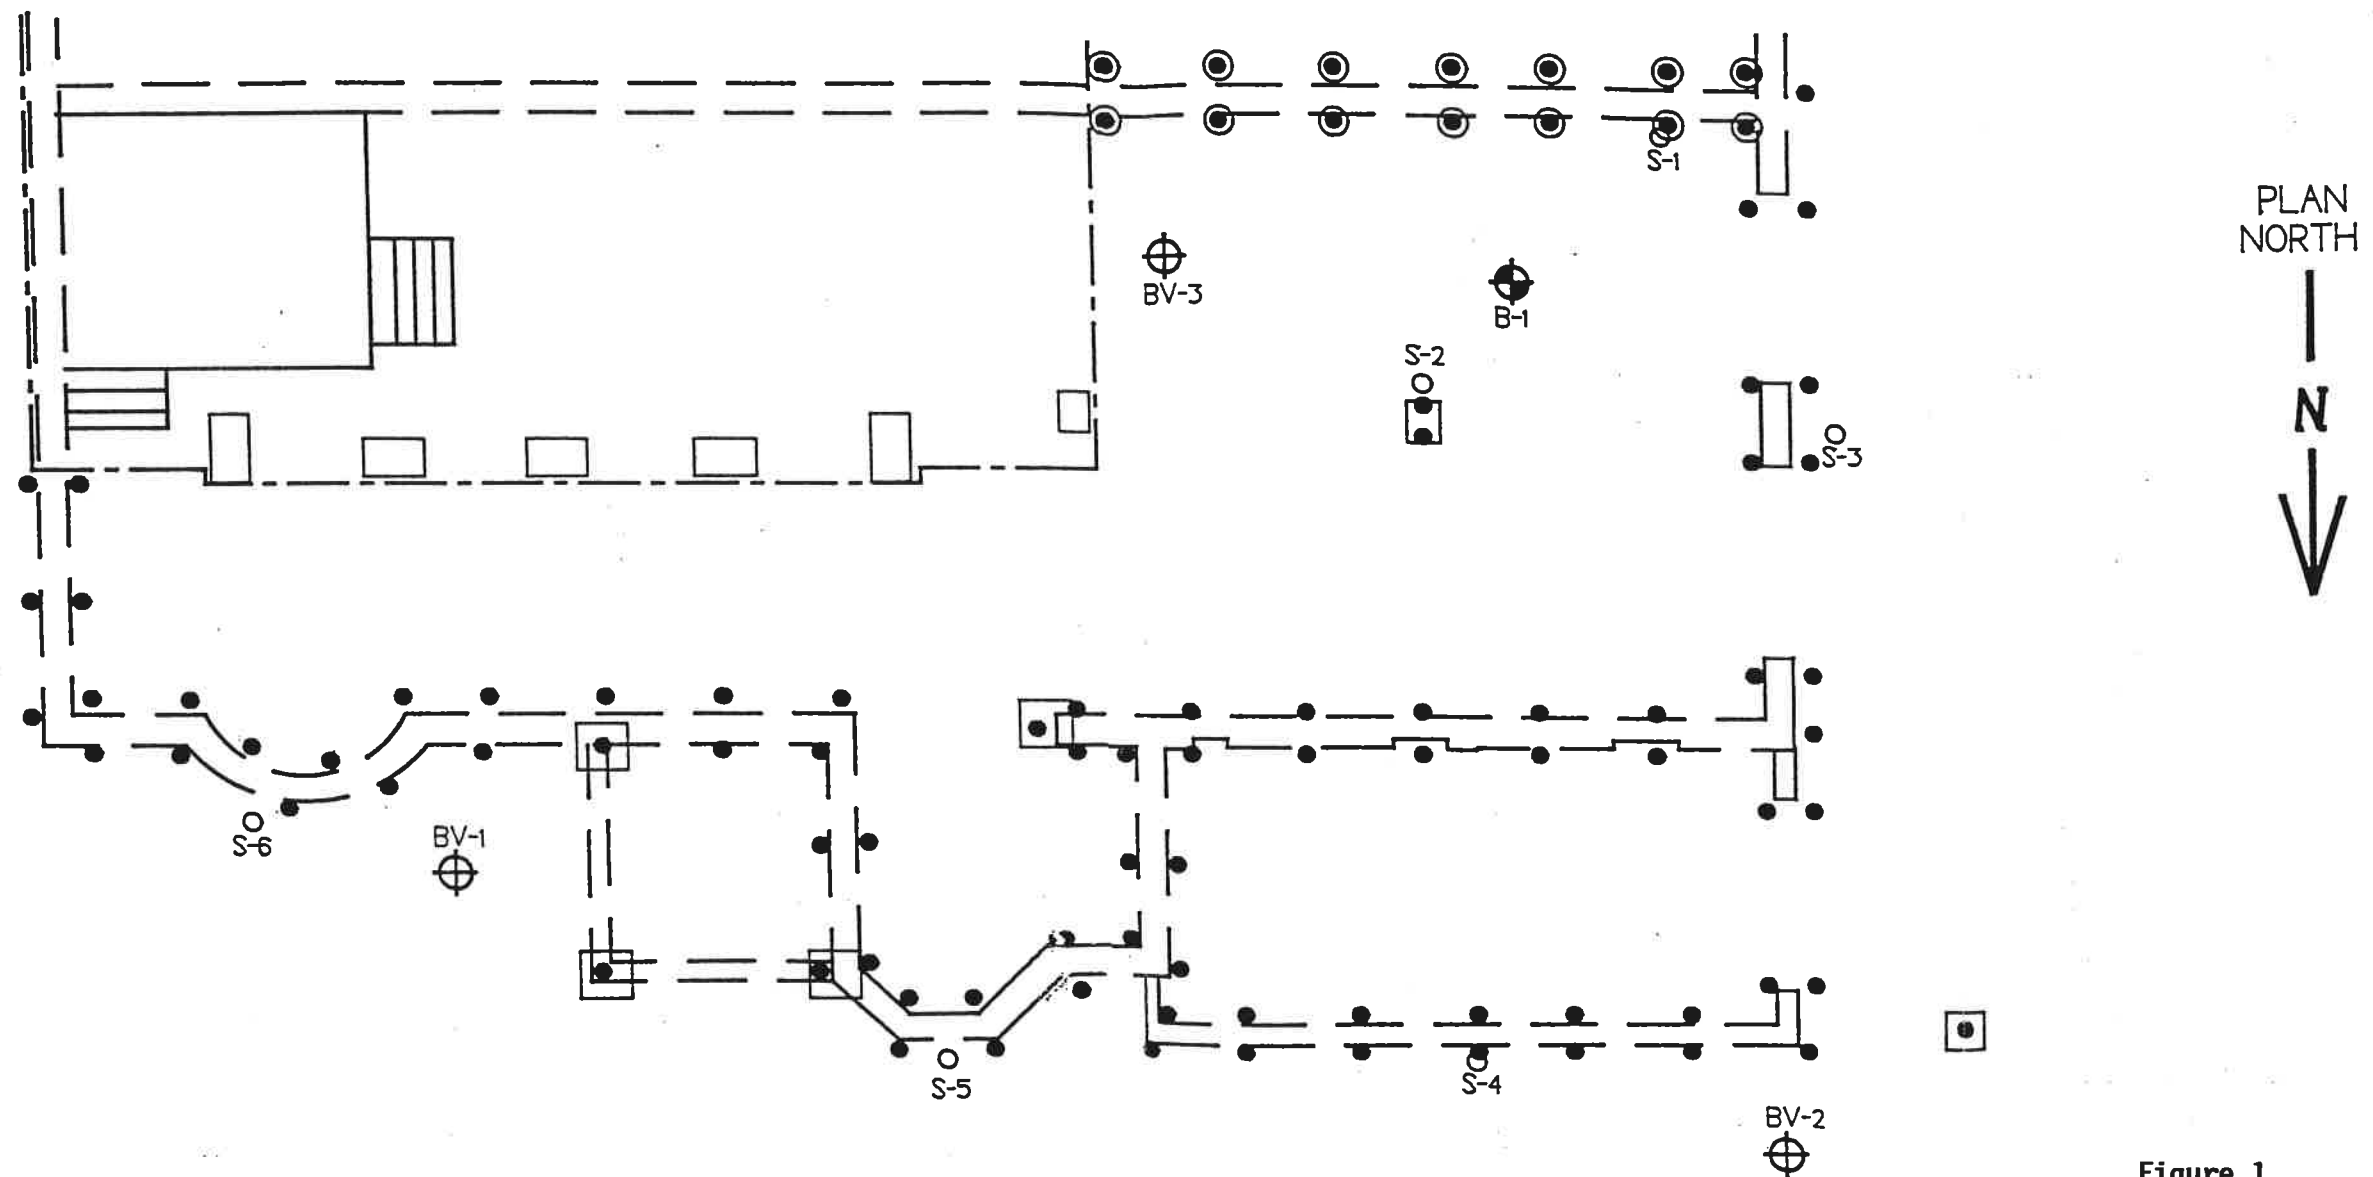
Figure 1

An engineering report prepared by Schnabel Engineering Associates, West Chester, Pennsylvania, dated 28/October/92 recommended various remedial alternatives to address the settlement problem, among which was the selected alternative, "compaction grout piles." The proposed layout and grout quantities of the compaction grout piles in Schnabel's report of 28/October/92 is presented as Figure 1. This original layout, which shows paired injection points on both sides of the load bearing walls to be compaction grouted, was subsequently modified to a single row grouting pattern. The modified unpaired grouting pattern recommended by Schnabel, (undated) is presented as Figure 2. The single row grouting pattern was further modified to accommodate the accessibility for the various compaction grout locations. This final injection point layout is presented as Figure 3. It is noted that in the initial Schnabel report, the paired grout hole layout scheme proposed the injection of two cubic feet and three cubic feet of grout per linear foot of grouted depth, as indicated in Figure 1. When the scheme was modified for the unpaired grout location scheme, the quantity for grout injection was doubled for each location. This increased quantity was used during the implemented grouting program performed.

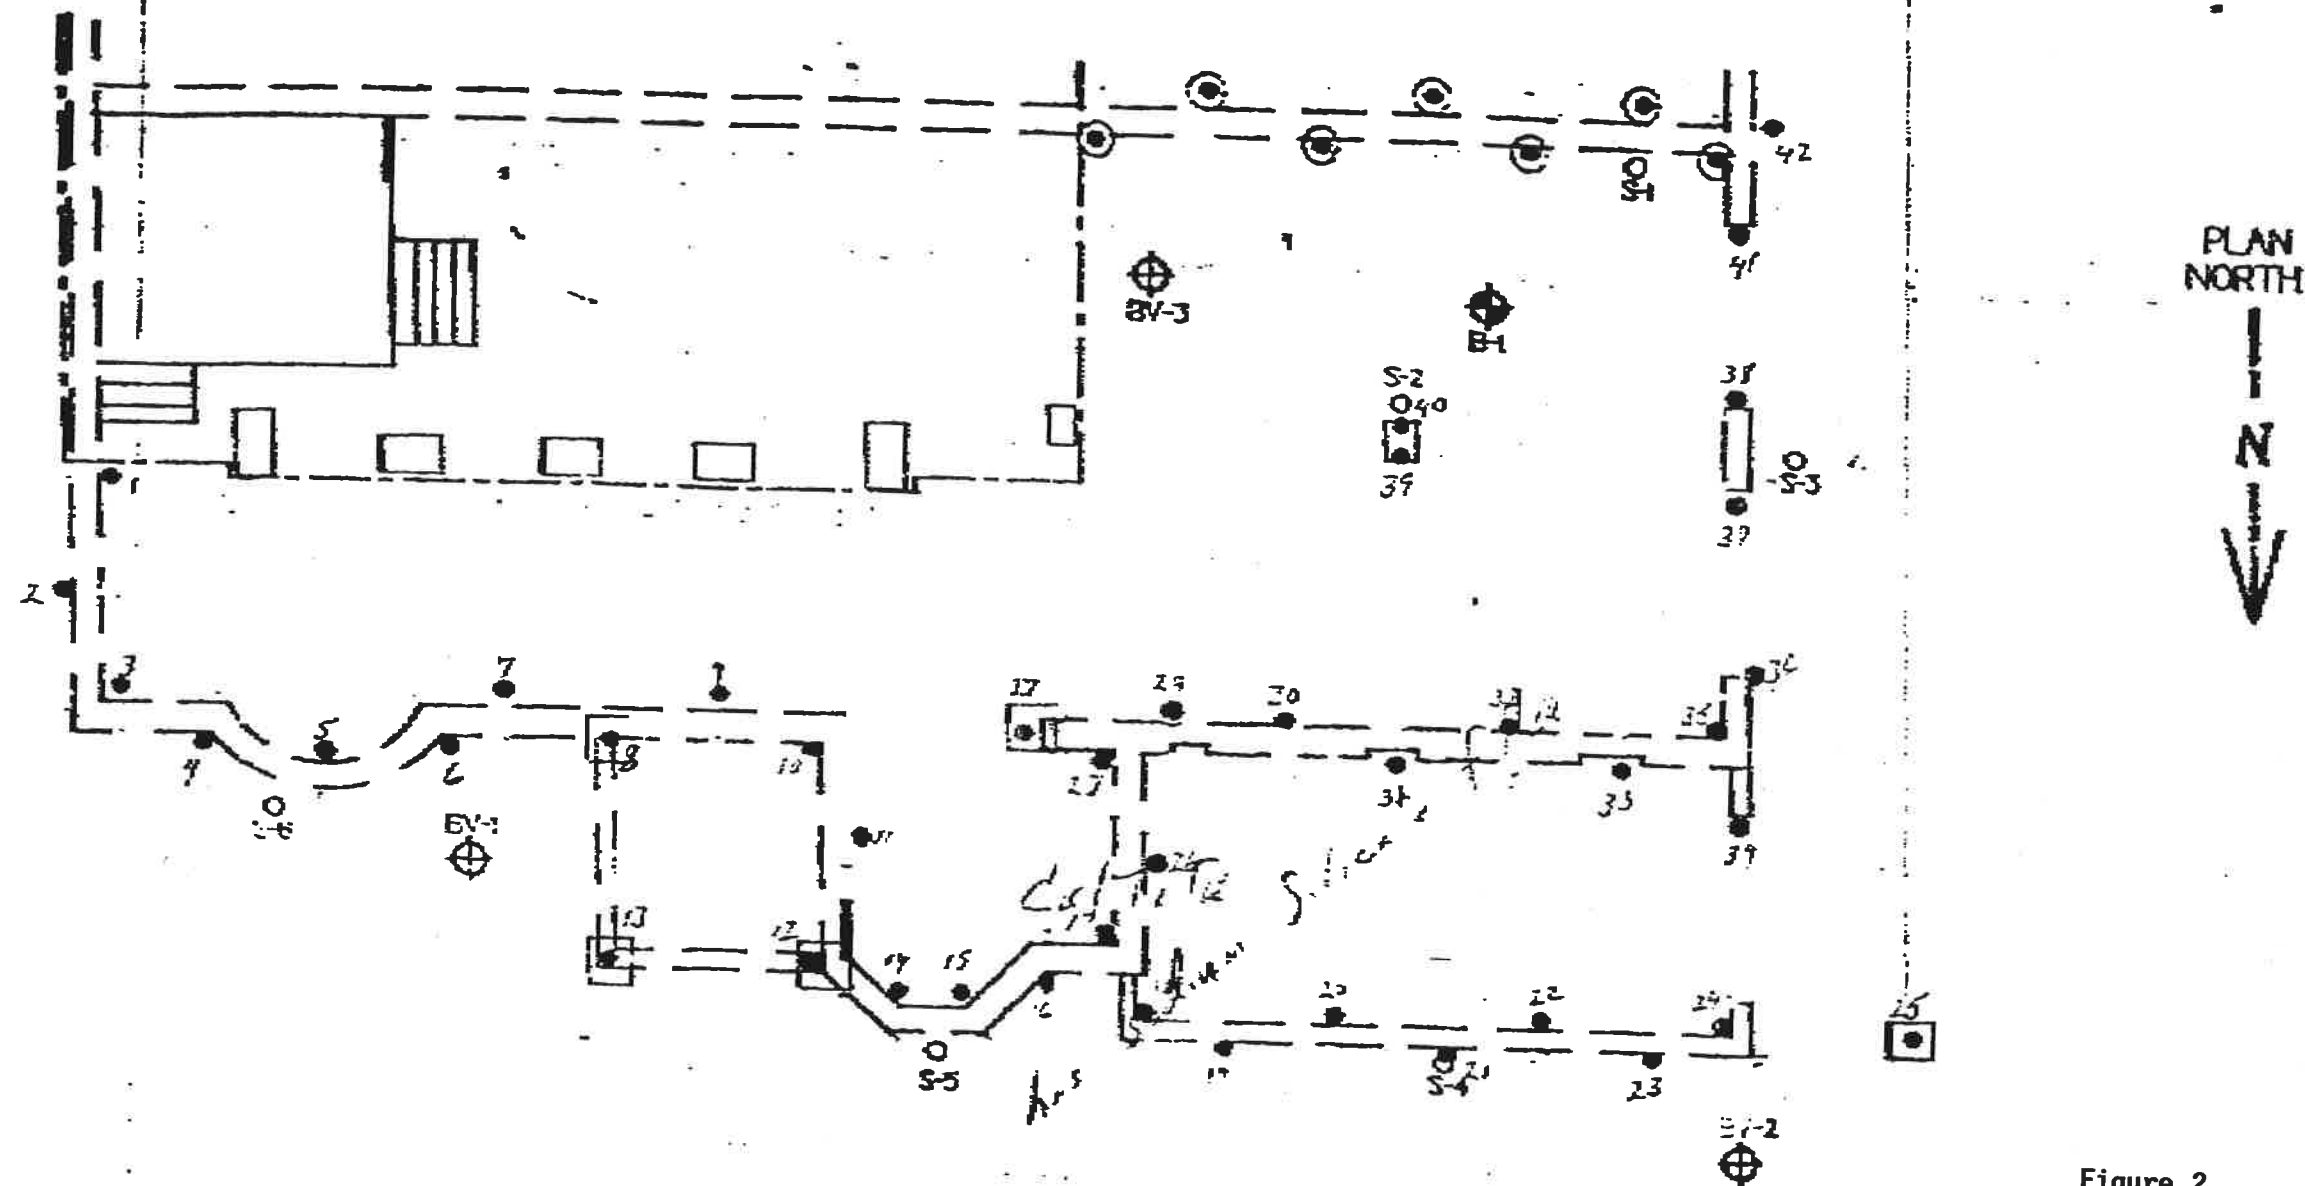
Figure 2

On 17/June a site meeting among the architect, Mr. Fred Kaulbach of Armstrong Kaulbach, Ms. structural engineer Ann Rothman, the contractor Mr. Joseph Harris (DGS), and Mr. C.R. Calabria (GSC) took place. During this meeting, the structural engineer approved the inject plan layout as presented in Figure 2, and suggested a grouting sequence for the party wall (i.e. pump the wall segment parallel to the river first, let set, then proceed with the wall segment perpendicular to the river). The grouting sequence

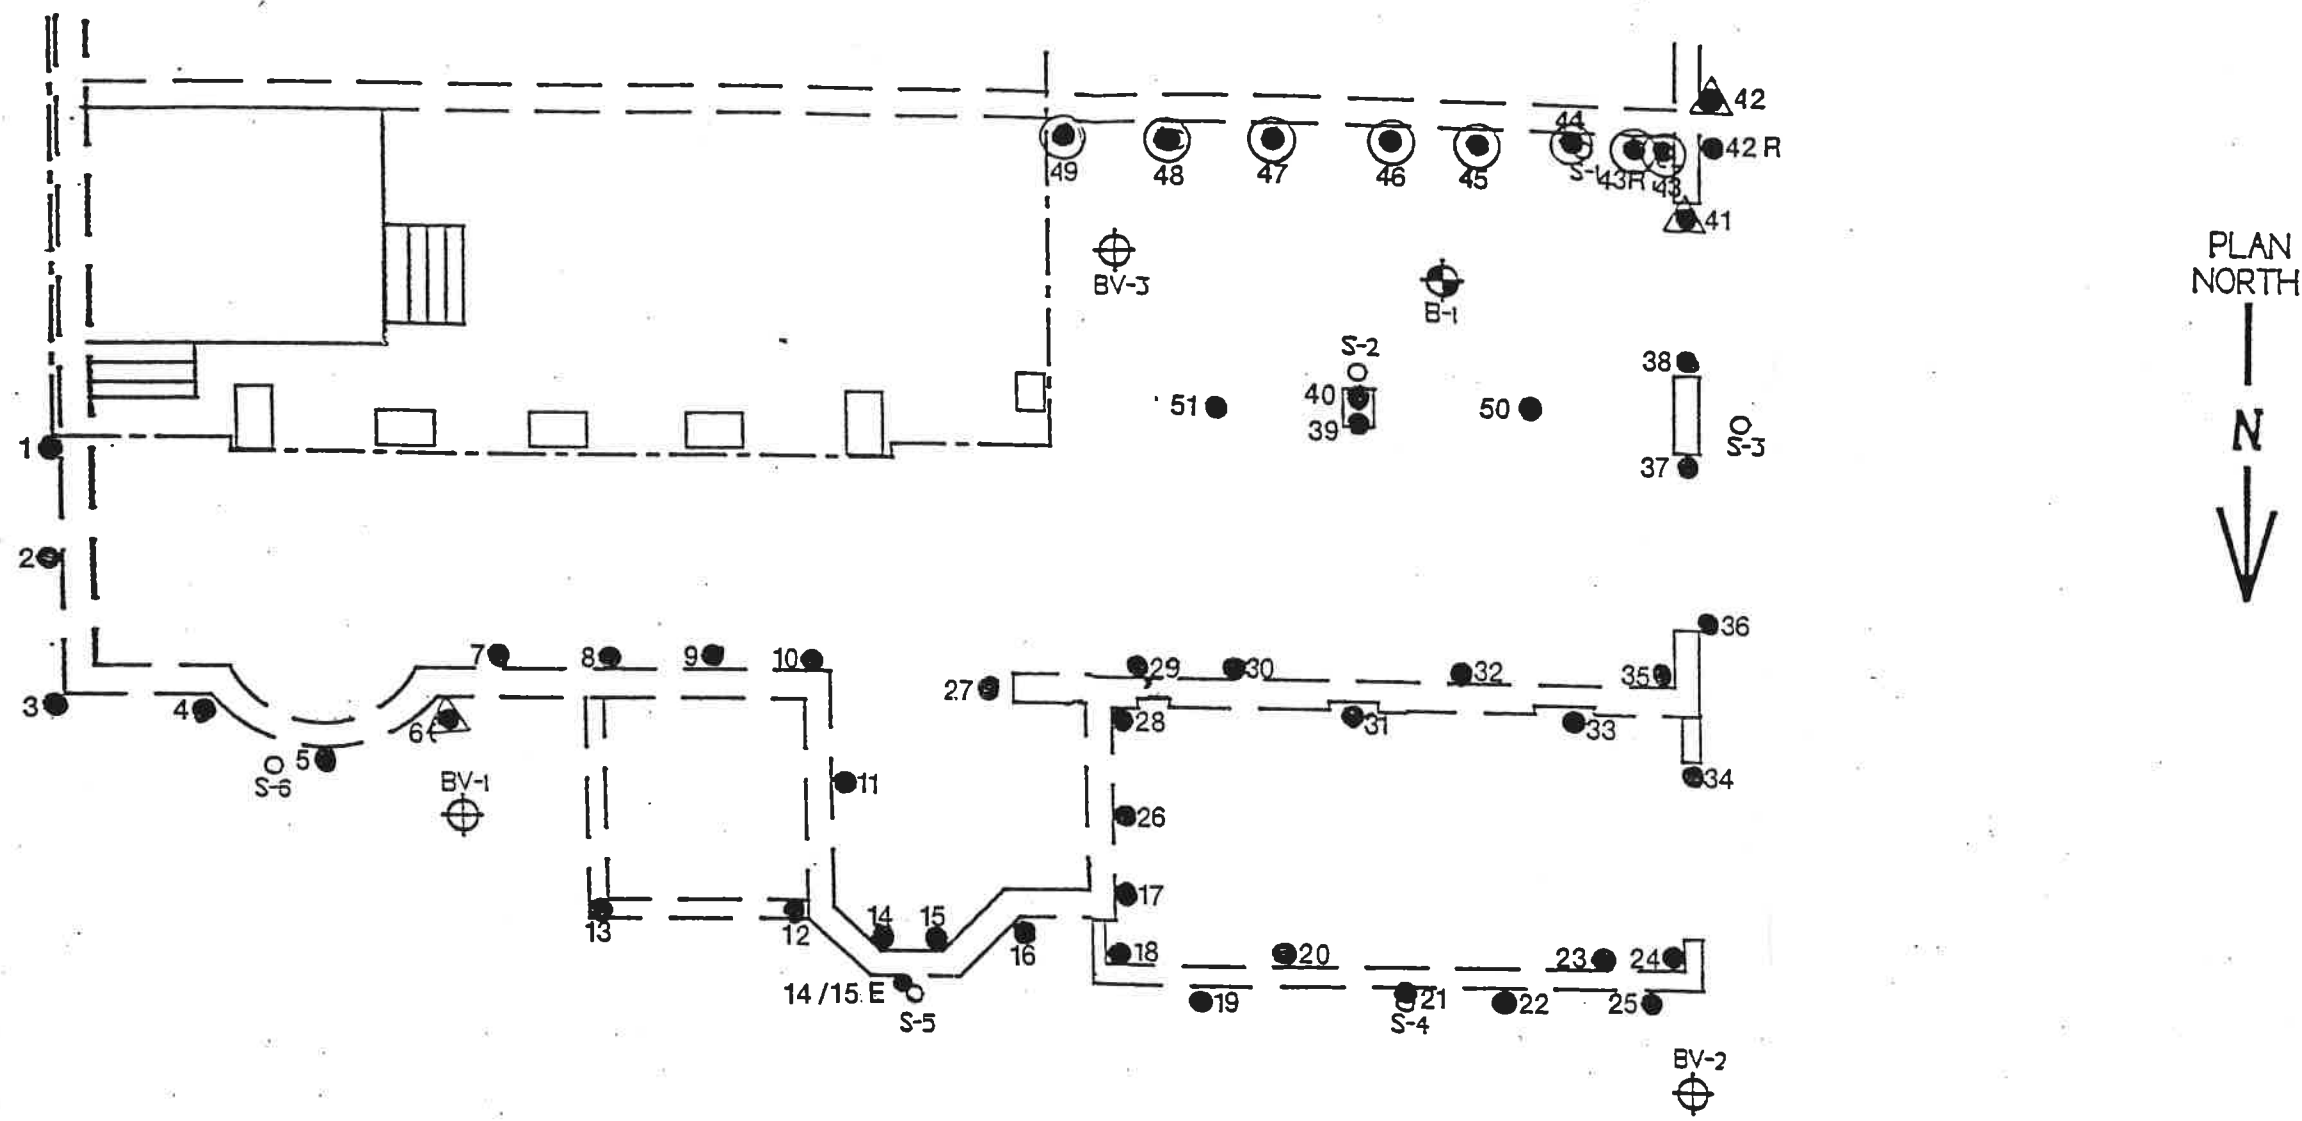
Figure 3

Based on our observations and review of contractor's documents, the work was performed in general accordance with requirements established in the Schnabel report, and modifications thereto, as noted in Figure 3. The exceptions to this included grout strengths were low for sample numbers 35, 41, 42, and 43, for samples collected on June 9, 14, 15, and 16, 1993, and an apparent uncompleted grout pier at location 35.
